**CANOE BROOK
RESERVOIR NO.2 DAM
NJ 00526**

**PHASE 1 INSPECTION REPORT
NATIONAL DAM SAFETY PROGRAM**

Name of Dam: Canoe Brook Reservoir No. 2,
I.D. No. NJ 00526
State located: New Jersey
County located: Essex
Stream: (Off-stream pumped storage)
Date of Inspection: November 29, December 16, 1978,
and January 4, 1979

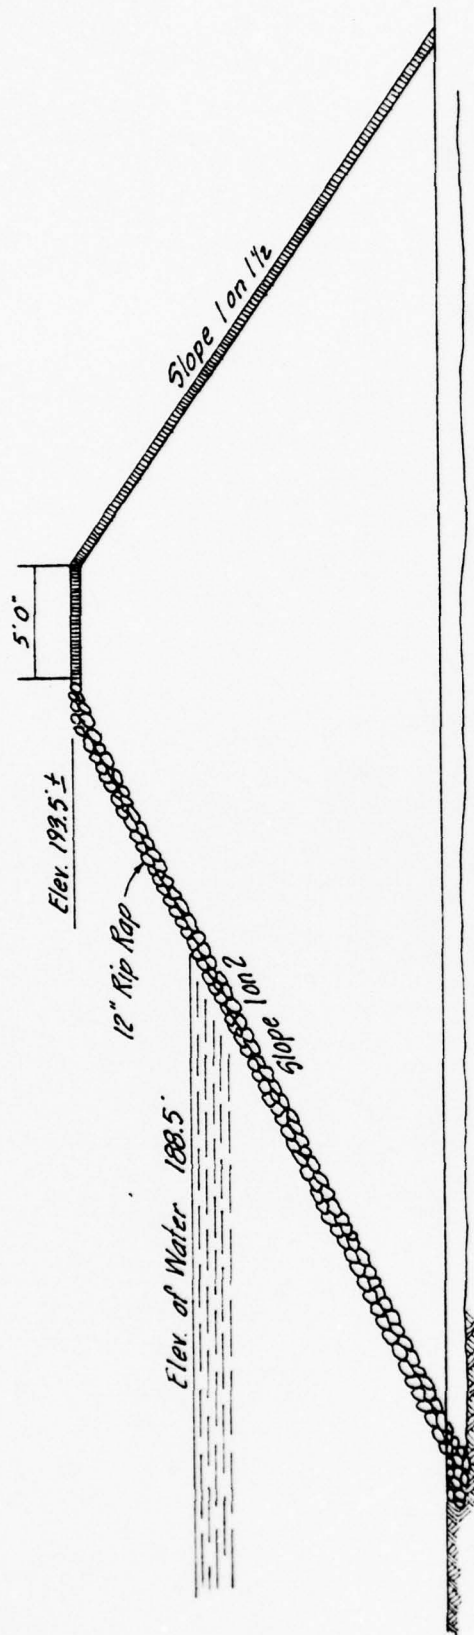
TYPICAL SECTION
CANOE BROOK DAM NO. 2

Note: Based on typical section of
Canoe Brook Dam No. 1,
plus field observations and
information from owner.

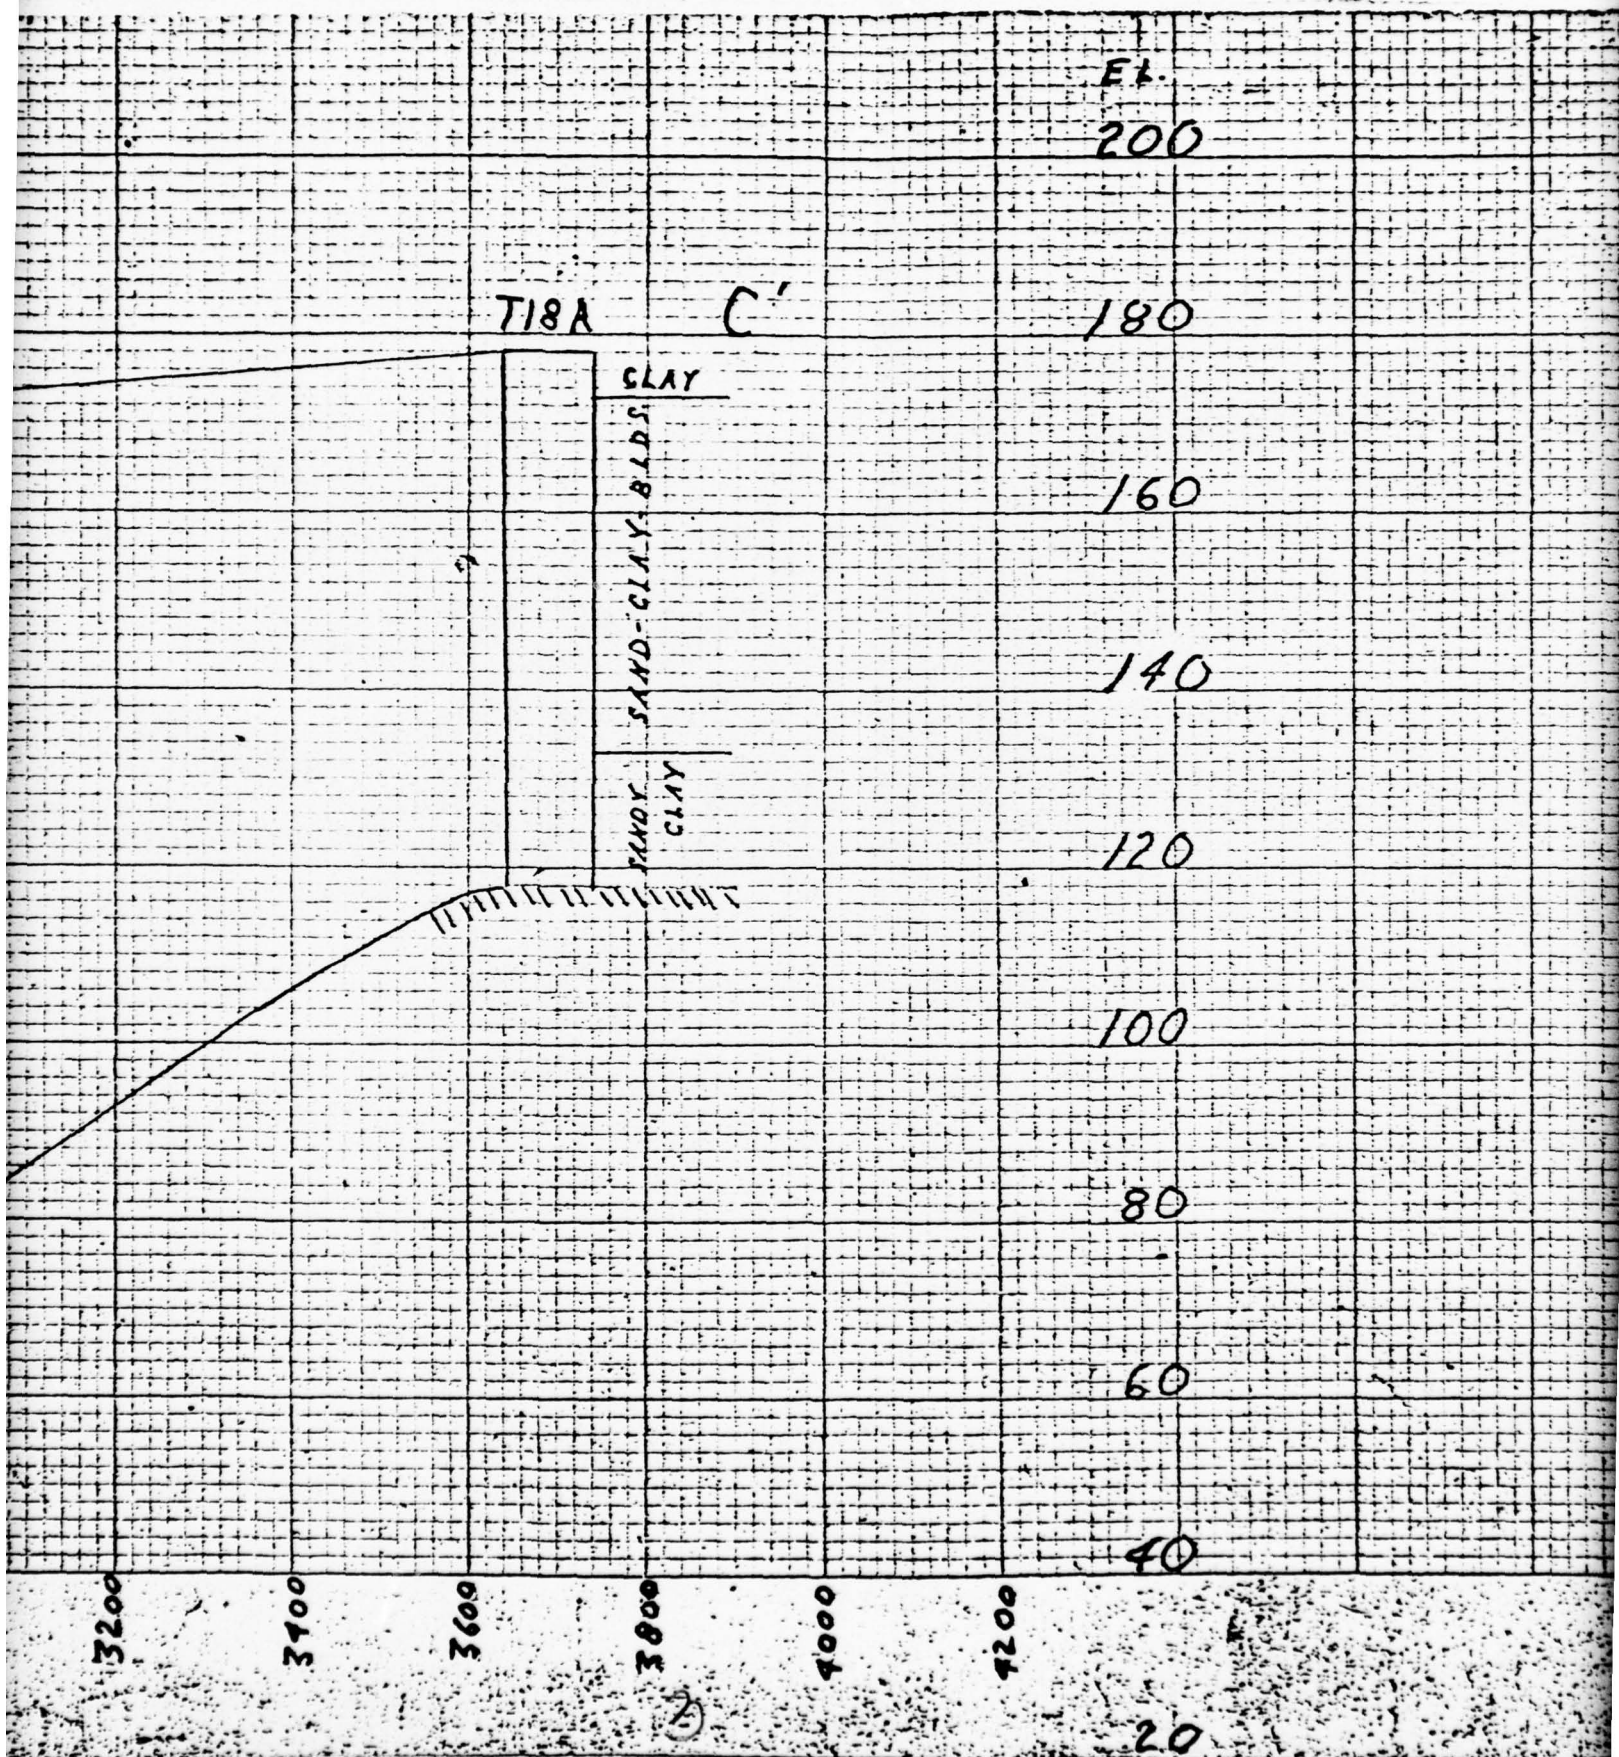
FIG. 6 - SEE FIG. 5

CANOE BROOK WELLS

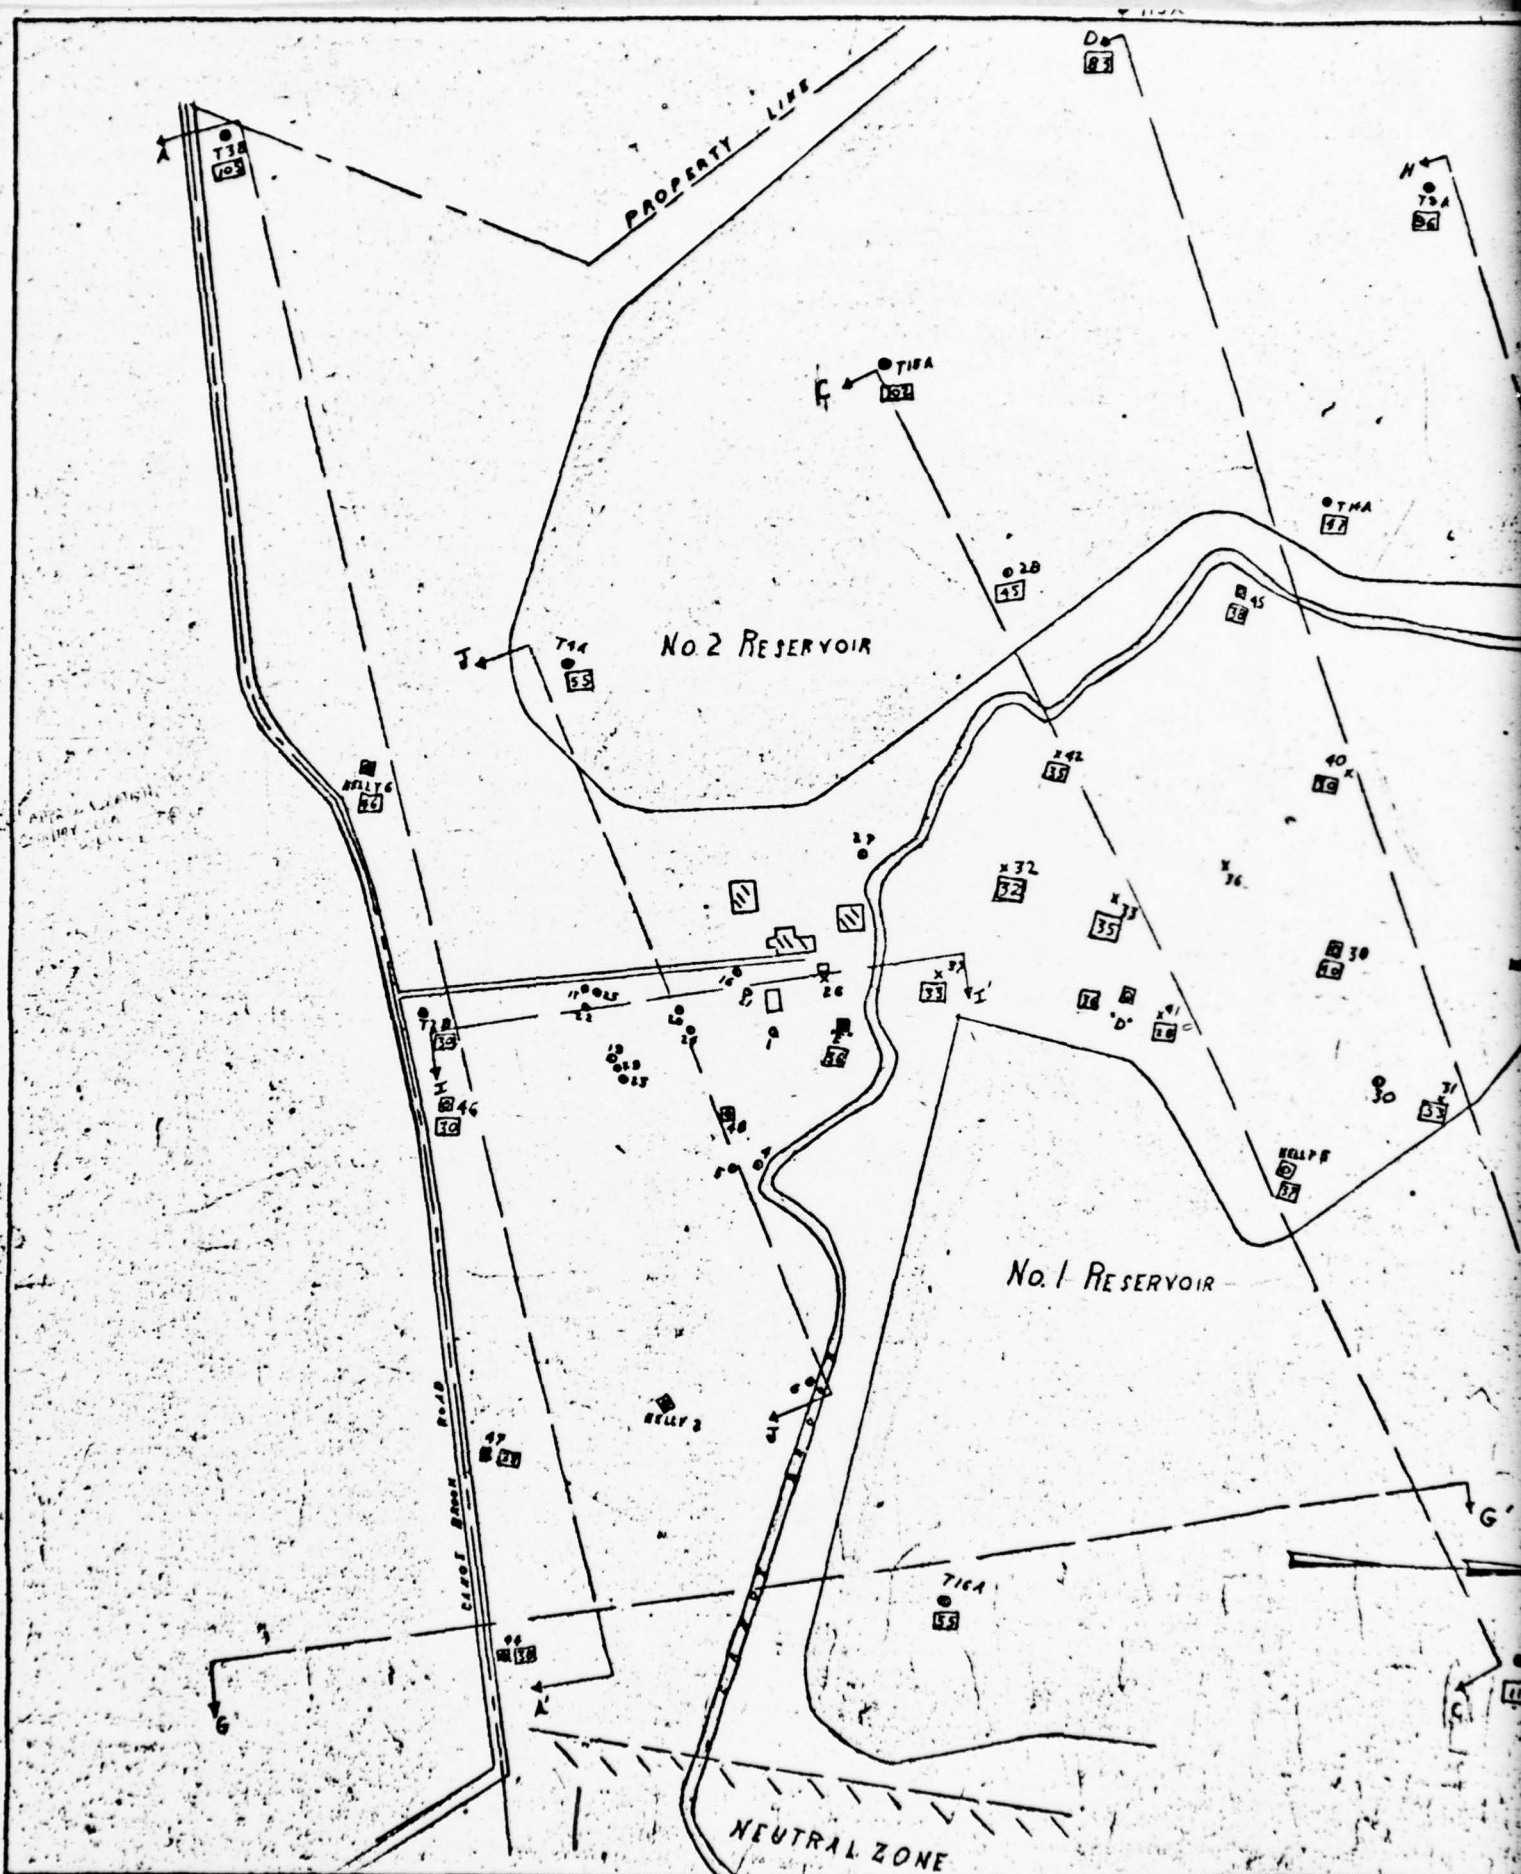
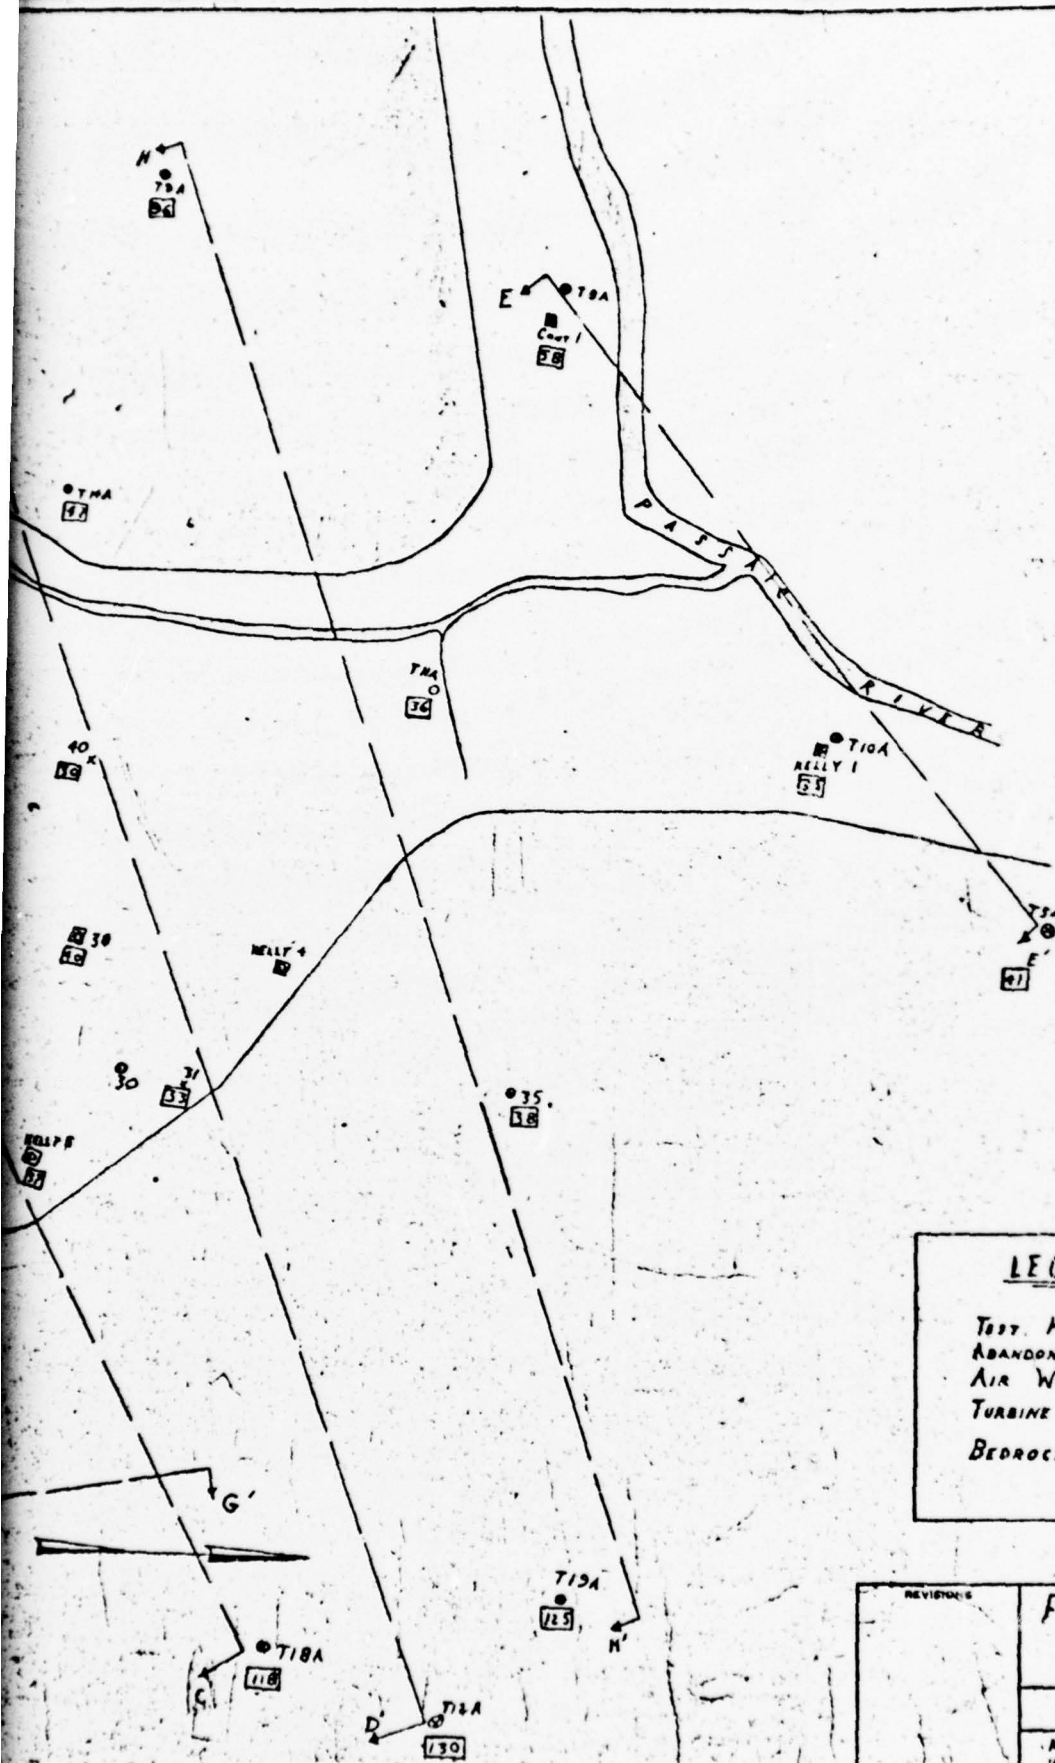
FIG. 5 WELLS AT THE CANOE BROOK STATION - SEE FIG. 6 FOR CROSS SECTIONS

the reservoir embankment. However, it is known by projection that the Brunswick formation of sandstones and shales underlies Reservoir No. 2. Logs of several water wells drilled in the area between Canoe Brook No. 1 and No. 2 are shown on Plate 5 and locations of these wells are shown on Plate 6. The logs indicate soils of clay and sandy clay near the surface and bedrock between 60 to 140 feet depth.

No records of construction are available. No soils tests are known to have been made of the embankment material. It was reported that the borrow material was derived from excavation within the present reservoir. Logs of nearby water wells indicate the near surface soils to be clay and sandy clay (Plates 5 and 6).
